Experimentation on The Integration of BIM and Laser Scanning Applications for Monitoring a Selected B+G+11 Apartment Building Construction Projects

Bethel Wubante Zewdu, Zekariyas Sintayehu Gebrekidan, Eyerusalem Kelemework Yigzaw, Bethel Melese Tamene, Kidus Dereje Milion

Debre Berhan University, Debre Birhan Ethiopia,
bethelwubante20@gmail.com, Zekariyassintayehu@gmail.com, eyerusalemkelemework@dbu.edu.et,
bethelmelese6@gmail.com, Kddking78@gmail.com

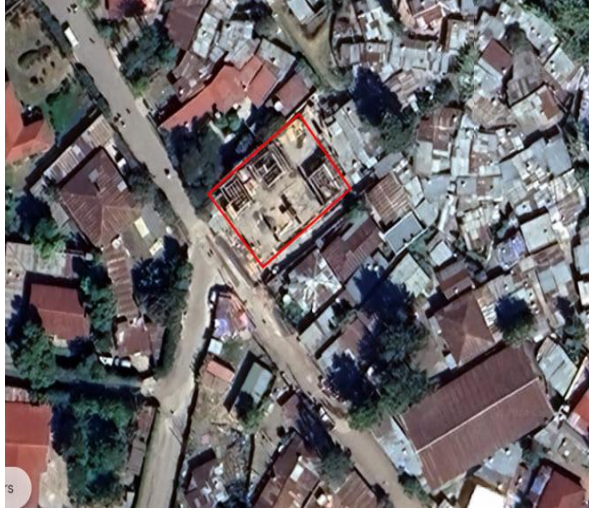
Figure 11: Adjustments of drone parameters

Figure 11 and Figure 12 show setting up the drone parameters as stated in Table 1. Two separate scans were taken where duration of the scan took 4 minutes each flight.

Table 1: DJI Mavic Lidar Scanner Drone Adjustment Parameters

Parameter	Value
Flight attitude	30m + 38m = 68m
Side overlap	80%
Front overlap	70%
Point cloud density	1347point/m3
Ground sample distance (GSD)	0.82cm/pixel

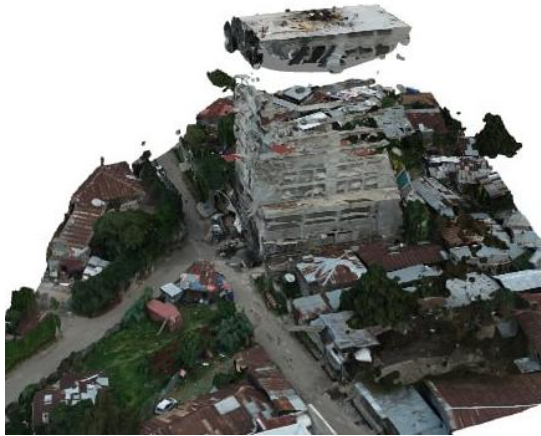
Figure 13: 1st Mission data processed using Autodesk Recap

During the 1st mission, a total of 25 images were captured with 2,703,112 points and an average density of 456.46 points/m. However, when converting the scan into 3D models, some areas were identified to be missed. As the picture in Fig 13 indicates the generated model was not satisfactory, hence the second trial was conducted using a Pix 4D mapper.

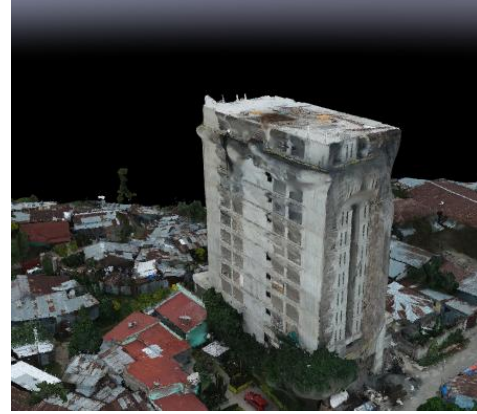
Figure 15: 3D Scanned model processed from the 2nd mission data using Pix 4D Mapper

The second mission contains 47 scanned images with 4,690,457 points with an average density of 432.18 points per m^3 . The processed 3D scanned Model is better than the first mission as indicated Fig 15.

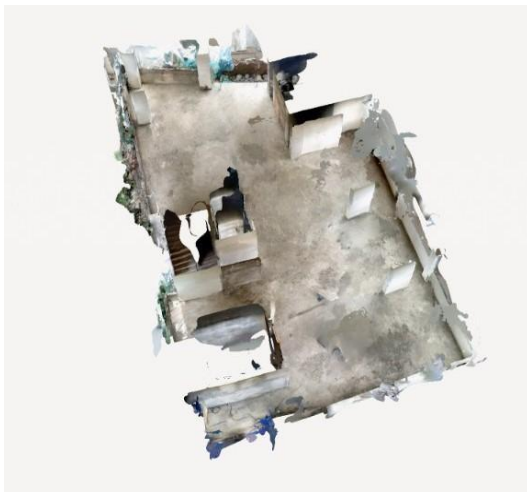
Figure 25: Comparison of 1st floor planed 3D model and actual progress of scanned model

For the internal work progress checking the 3D planned model was of the first floor was computed though visual check of the scanned model. By comparing as planned model incomplete works are easily identified.
