Investigation and Redesign of the Highway Stormwater Management System to Mitigate Gully Erosion, and Enhance Drainage Infrastructure Resilience; Case in Gokwe Town, Zimbabwe

Farai Kufa, Pride Mutekwa

Construction and Civil Engineering Department, University of Zimbabwe,
P.O. Box MP 167, Mount Pleasant, Harare, Zimbabwe,
kufafarai3@gmail.com, mutekwapride@gmail.com

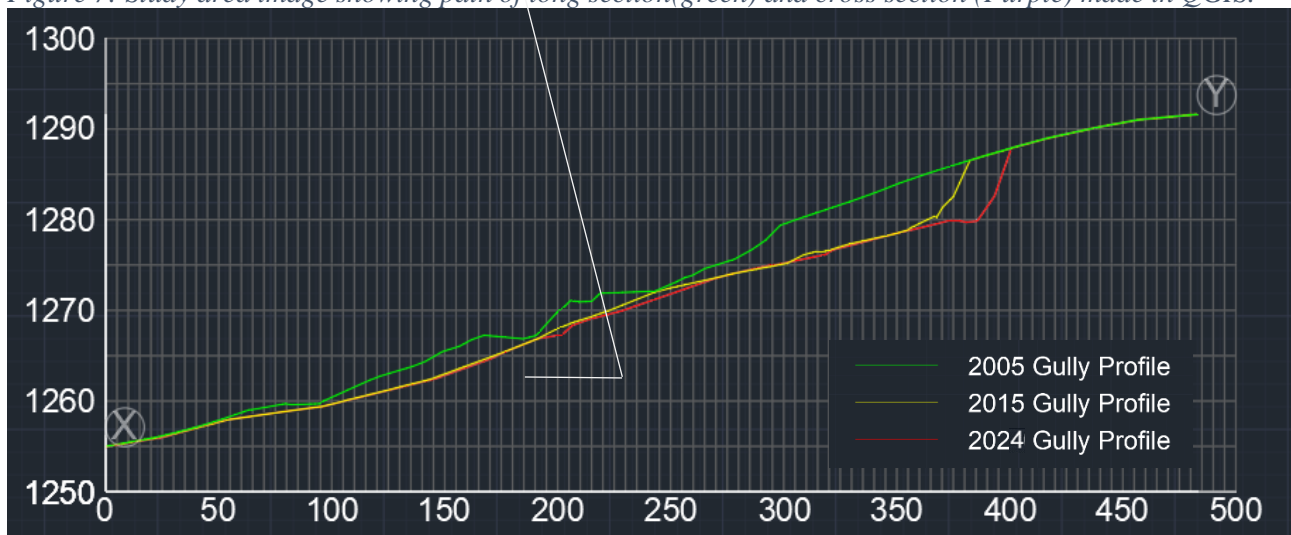
In order to demonstrate that the growth is not a typical drain channel for received precipitation but rather develops over time, with each rainfall event partially contributing to the gully development, the channel profile of the gully was found to accommodate a volume flowrate larger than would be practical given the rainfall intensity of Gokwe and greater than the accumulated runoff and area.

Figure 8: Gully Long section over time as created in Civil 3D (units in meters).

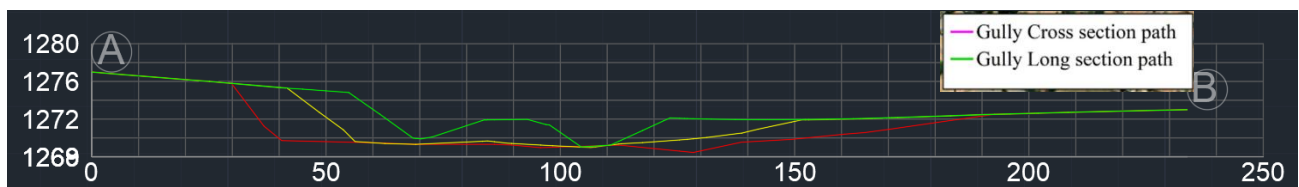
Figure 9: Gully Cross section showing profile over time in Civil 3D (units in meters).

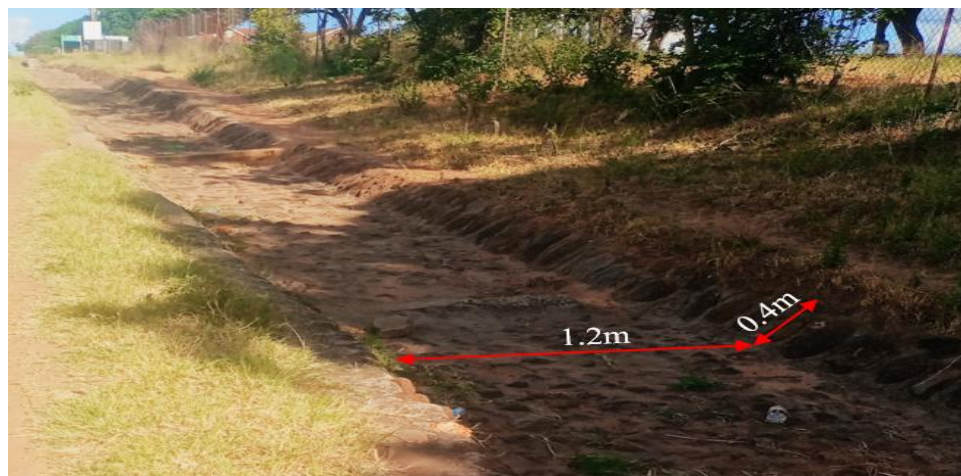
The key drainage improvement opportunities for the system include upgrading of undersized driveway culverts, and reducing the load on the overall system by provision of cross culverts discharging to stable or protected slopes through slope drains since the slope and soil type are never favourable to runoff generation. Figure 12 shows the existing drain on site which was used to determine the estimated flow capacity.

Figure 12: Size estimation of the existing drain on the side of the road adjacent to the gully.

Table 1 shows the capacity and level of operation of the existing drain. The 120% drain discharge indicates how the existing drain has become insufficiently small for the generated runoff as should normally be leaving a freeboard of around 20% (Specialist et al., 2006)

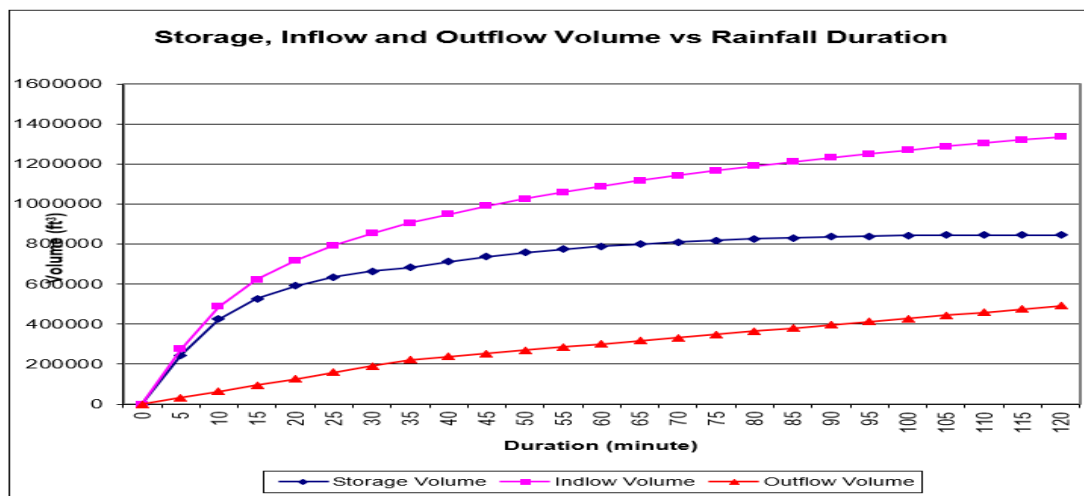
An irregular shape of detention pond was designed to hold a volume of **23,92m³** storage volume as determined and shown in Fig 14. Figure 15 also includes a layout of the designed pond as drawn in Civil 3D. The detention volume estimated by the Modified FAA Method for:

- Area = 167.5acres
- Runoff coefficient = 0.8
- Time of Concentration = 35min
- Return Period = 5years
- Using a maximum allowable release rate (MARR) of 40% $= 0.4 \times 7.47$
 $= 2.99\text{m}^3/\text{s}$
 $= 105.5\text{ft}^3/\text{s}$

Figure 14: Storage, Inflow and outflow volumes vs Rainfall duration.
