Assessment of Groundwater Quality and Faecal Contamination Risks Underneath the Qoboza Klaaste Building, University of Johannesburg

Moosa Phulwana¹, Patience Davhana¹, Mondli Mthombeni¹

Abstract

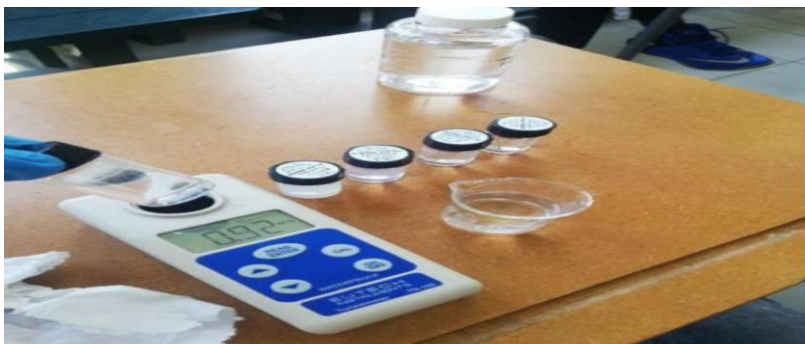
Fig. 4: 18 Test kit – Colilert method (Source: University of Johannesburg, Water and Health Research Centre (2019))

Total Coliform and E. coli samples were investigated in the Water and Health Research Centre (WHRC) in the University of Johannesburg at Doornfontein Campus (UJ DFC). Analysis was done using IDEXX Colilert-18 method as shown (Figure 4) which is a selective and specific substrate technology that is aimed at the simultaneous detection of the bacteria.

In this study, water samples were collected in the basement in different sump pits (figure 3) daily using clean and disinfected beakers and taken to the laboratory (figure 4) for test, assessment the suitability of groundwater for human consumption. The turbidity was measured using the TN 100 turbidity meter using 30 ml primary standards of 0.02, 20.0, 100, and 800 NTU to measure the turbidity. pH, electrical conductivity (EC) and temperature was measured using a Hanna HI 98129 waterproof meter. The HI 98129 meter was first calibrated with pH buffer solution (4, 7, 9) and EC with a standard conductivity solution to make sure it was accurate. The temperature was measured by turning on the meter and dipping the probe in a 30 ml beaker of sample water. The other samples were taken to the University of Johannesburg water lab for testing of microbiology and physical parameters for this research. All analytical results were evaluated and compared with the national standards for drinking water

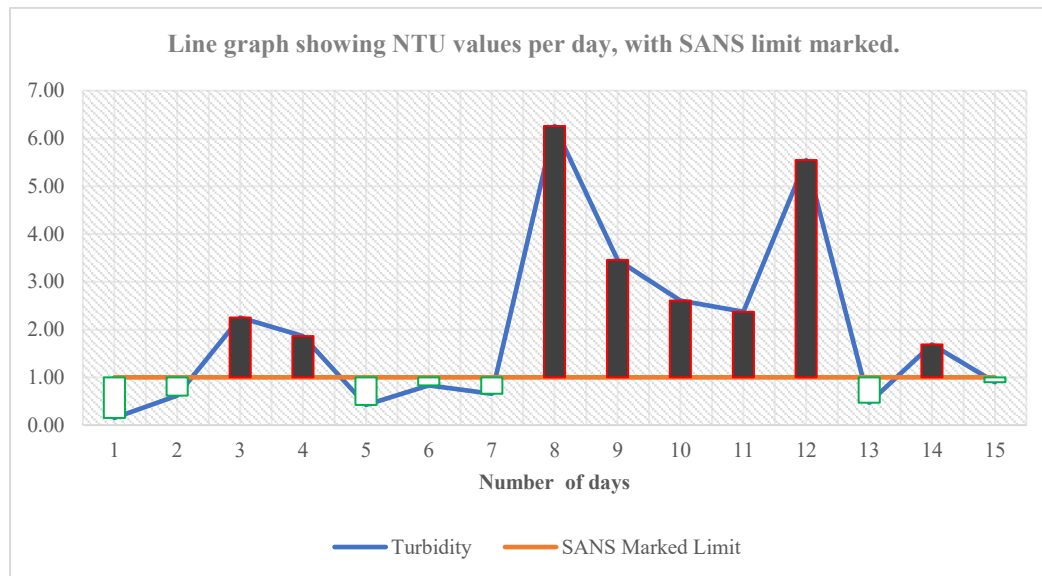
Fig. 5: Turbidity Trends Over Sampling Period

Turbidity values ranged from 0.5 to 6.26 NTU, with only 7 out of 15 samples (fig.5) meeting the SANS 241:2015 limit of ≤ 1 NTU. Elevated turbidity compromises aesthetic quality and may shield pathogenic microorganisms from disinfection processes. The observed exceedances are likely attributable to episodic contamination events, notably mechanical failures in the sump pit system. On days when sump

pumps malfunctioned, overflow and backflow of water into the pit were reported, facilitating the reintroduction of contaminated water into the groundwater system. This mechanical failure likely mobilised fine sediments and suspended particulates, contributing to the elevated turbidity levels observed.

This study investigated the quality of groundwater in the Q/K Building at the University of Johannesburg's Doornfontein Campus by analysing its physical and microbiological parameters in accordance with SANS 241:2015 standards. The findings revealed that while the groundwater exhibited acceptable pH (6.5–7.6) and electrical conductivity (26.5–48.9 mS/m) values indicating low mineralisation and minimal influence from Acid Mine Drainage (AMD), turbidity levels exceeded permissible limits in more than half of the samples. These elevated turbidity readings were linked to mechanical failures in the sump pit system, which allowed contaminated water to re-enter the groundwater reservoir, suggesting a direct pathway for physical contamination.
